SERVICE BULLETIN

No. 899-CH

CARBURETOR

No. 905-CH

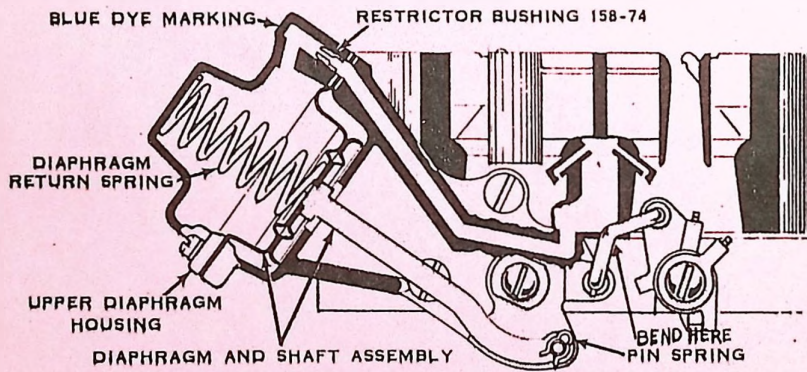
CROSS SECTION DIAPHRAGM AND HOUSING

SENSATION OF LACK OF COMPLETE CONTROL OF ENGINE SPEED ON DECELERATION AT SPEEDS IN EXCESS OF 60 MPH

1. Restrictor bushing 158-74 has been released and installed in late production carburetors to slow the closing action of the vacuum operated secondary throttle valve.
 - a. Code date "A-5" or a blue dye on the diaphragm housing vacuum passage (see illustration) indicates the restrictor bushing has been installed in production.
 - b. The restrictor bushing 158-74 may be installed in early production carburetors by removing the upper diaphragm housing and diaphragm return spring. Press restrictor bushing into place (see illustration). Remove pin spring, disconnect diaphragm shaft at lower end, flex diaphragm to its lowest position, hold it there and reinstall diaphragm return spring, diaphragm housing. Tighten the cover screws alternately and evenly.
 - c. Attach diaphragm shaft at lower end and install pin spring. (See illustration)

Carburetor must be on the engine to check the above described conditions. Once it has been ascertained the correction is necessary, after following the above procedures, remove carburetor and deliver it to the nearest Carter service station for servicing. This will avoid the necessity of taking the vehicle to the Carter service station, inconvenience to the owner, and allow the Carter service station to properly schedule his work.

Carter service accounts will replace complete body flange assembly on the carburetor on a warranty (no charge) basis. Expiration date of this exchange is May 1, 1955.

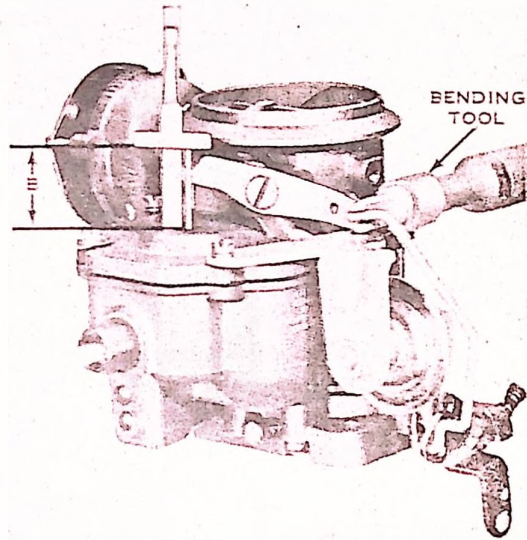
FIGURE 1
 PUMP ADJUSTMENT

It is possible that you may receive a report of a stumble or stalling condition on the Windsor engine during warm-up. This condition usually occurs while the choke valve is moving from the fully closed to the fully open position. To correct this condition, carburetor repair kit No. 1631449 (CARTER 195-59U) has been released. This consists of a venturi cluster cover and tube assembly, new set-up piston spring, step-up wires, and a new accelerator pump plunger assembly. The following instructions cover the installation of this kit:

8. Adjust accelerator pump plunger stroke. Back out throttle adjustment screw and open choke valve so that throttle valves seat in bores of carburetor. Install throttle connector rod in outer hole (medium stroke) of throttle lever and inner hole of pump arm. The distance from the top of plunger shaft to bowl cover (not pump arm) should be $29/32''$. Adjust by bending pump connector rod (2180S) at lower angle; (2162S) at upper angle (use tool T109-213).
