# CHRYSLER CORPORATION

## SERVICE BULLETIN

No. 954-CH

Feb. 23, 1956

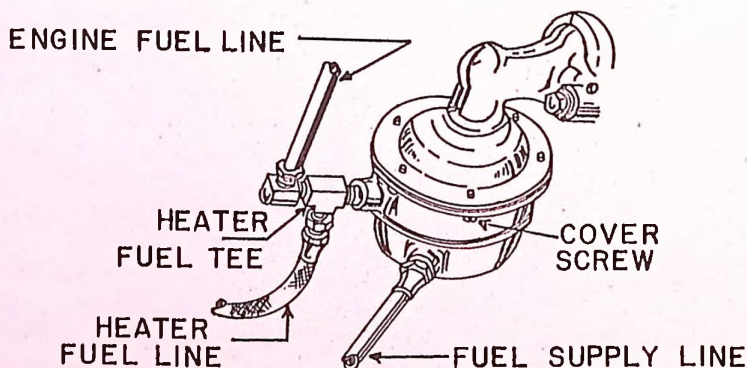
HEATER AND ENGINE FUEL LINE CONNECTIONS

Air bubbles in the fuel supply may sometimes cause intermittent operation of the instant heat conditionaire and also contribute to low heat output. These air bubbles are too small to affect engine operation but possibly will impair operation of the heater.

There are two possible sources of these air bubbles. They are (1) the engine fuel pump and (2) the heater fuel line.

1. Tighten engine fuel pump cover and rocker arm housing screws.
2. Insure that the heater fuel take-off tee in the outlet of the engine fuel pump is pointed vertically downward.
3. Start the engine and turn the heater on. Loosen the heater fuel line at the inlet to the heater fuel pump and bleed the air out of the line; then tighten the connection and check all fittings very carefully for leaks while the engine is running.
