SERVICE BULLETIN

No. 974-CH

FAN BELT
SQUEAK

ALL 1956
MODELS
WITH DUAL
BELTS

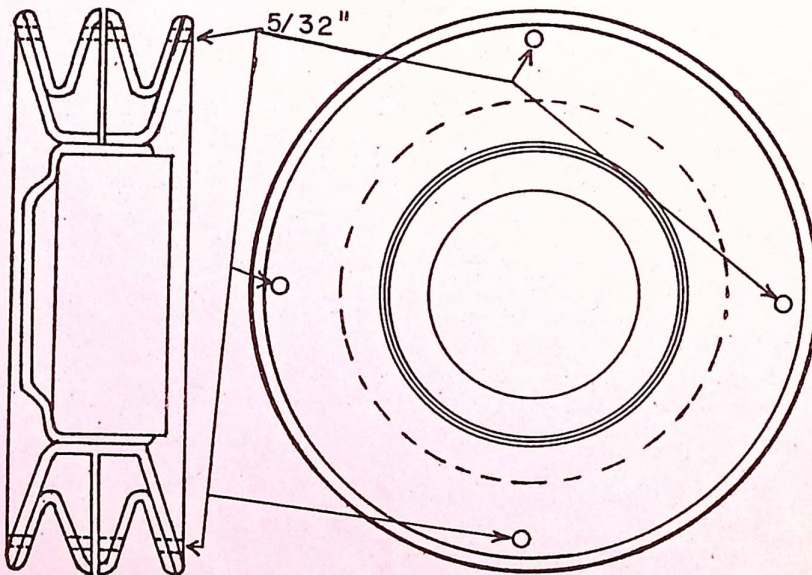
Should you encounter a condition of squeaking fan belts on dual belt installations, better belt traction can be obtained by drilling a series of holes in the idler pulley as follows:

1. Remove the idler pulley.
2. Determine the pitch line or belt contact area on the pulley.
3. Securely fasten the pulley and using a drill press or suitable means, drill four $5/32$ " holes, 90° apart, completely through the pulley. All of these holes should be in the belt contact area.

4. Reinstall idler pulley being sure it is properly aligned with fan and water pump pulleys.
5. Adjust belt tension.
