SERVICE BULLETIN

TECHNICAL INFORMATION ON IMPERIAL CHRYSLER PLYMOUTH VALIANT

No. 63-102

COMPRESSOR
CLUTCH
FIELD COIL

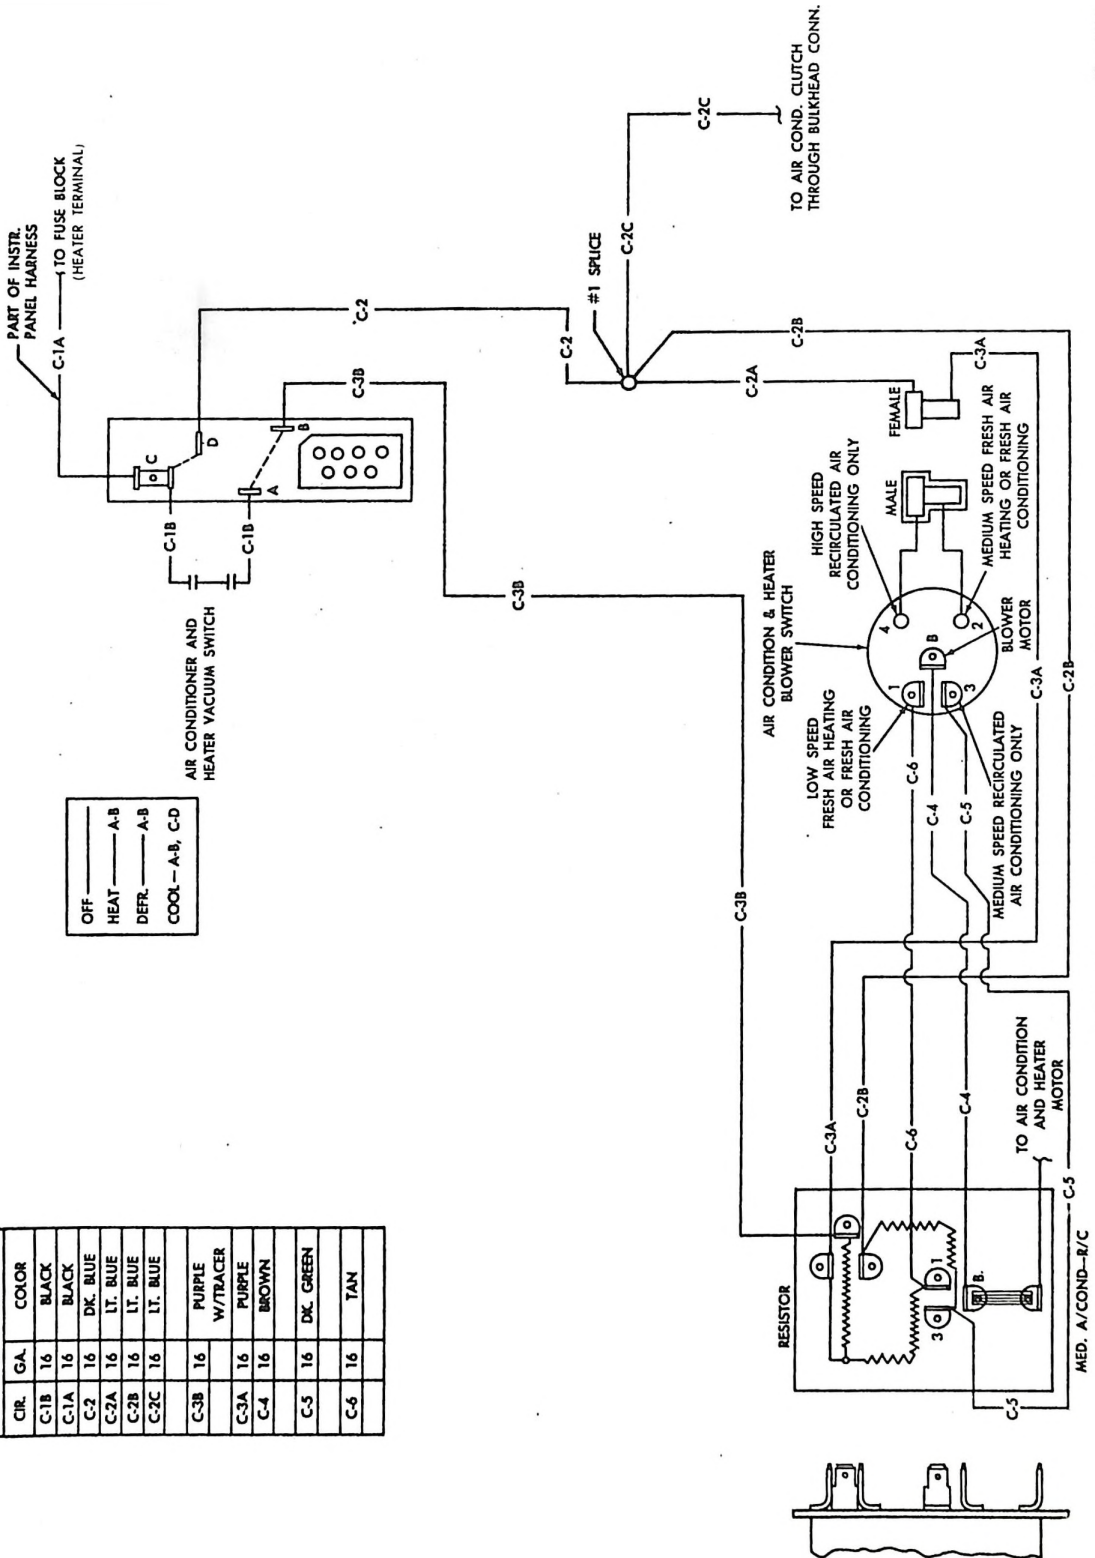
1963 Plymouth Electrical Control Circuit

During the later part of November, 1962, improvements to the air conditioning and heater electrical control circuits were incorporated in production. The blower motor relay located on the evaporator housing was eliminated and the control circuits wiring was simplified.

The electrical control circuits wiring diagram shown in Figure 10 on page 24-7 of the 1963 Plymouth-Valiant Service Manual applies to the early production models equipped with a blower motor relay. The attached wiring diagram applies to the late production models which do not have a blower motor relay.

Please insert the attached wiring diagram in your 1963 Plymouth-Valiant Service Manual.

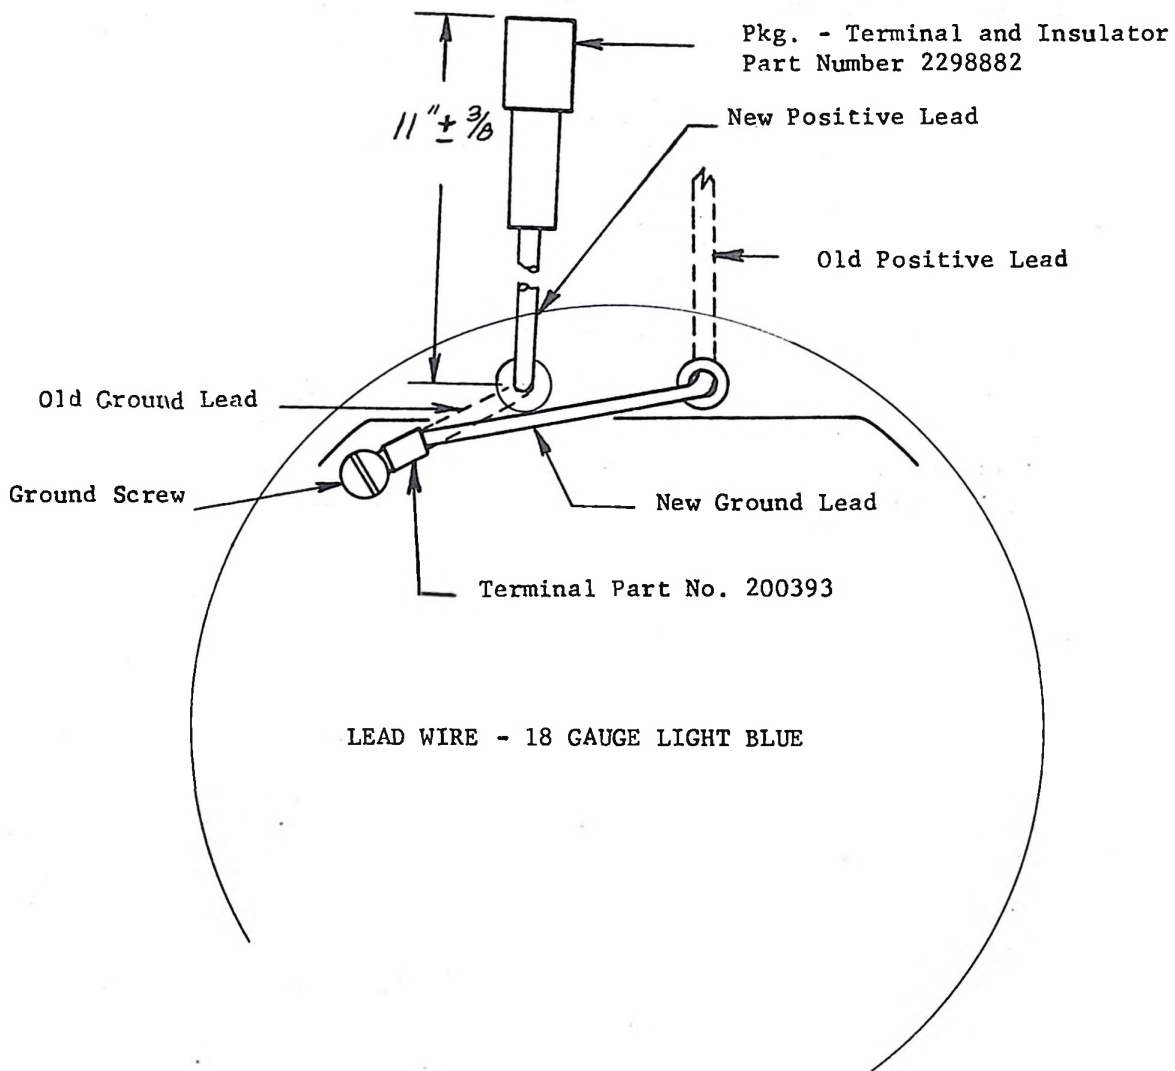
ASSEMBLY - AIR CONDITIONING COMPRESSOR
DRIVE CLUTCH FIELD COIL

If you encounter a fuse failure on the air conditioning compressor clutch coil circuit, the condition may be the result of the lead wire from the coil winding, grounding on the coil field housing. On 1963 models only, this condition may also result in inoperable electric window lifts, auto pilot and rear window defogger, as they are protected by the same fuse.

FIELD COIL REVERSE GROUND AND POSITIVE LEADS

If a clutch field circuit fuse failure occurs, the following clutch field coil lead modification should be performed to prevent a fuse failure recurrence.

- (1) Remove the clutch coil from the compressor and place it flat with the wire leads in an upward position. Refer to the illustration on page 2.
- (2) Remove the ground screw from the ground lead and housing.
- (3) Cut the ground lead and splice a piece of No. 18 gauge wire, attach a Terminal and Insulator Package, Part No. 2298882, to the wire, The total length of the wire from the face of the housing, to the end of the insulator should be 11 inches plus or minus 3/8 of an inch. This will now be the new lead wire.
- (4) Cut the original lead wire to 2 inches and attach a terminal Part No. 200393. Attach this new ground lead to the housing with the ground screw previously removed.
