# SERVICE BULLETIN

No. D-37

Defroster

Control

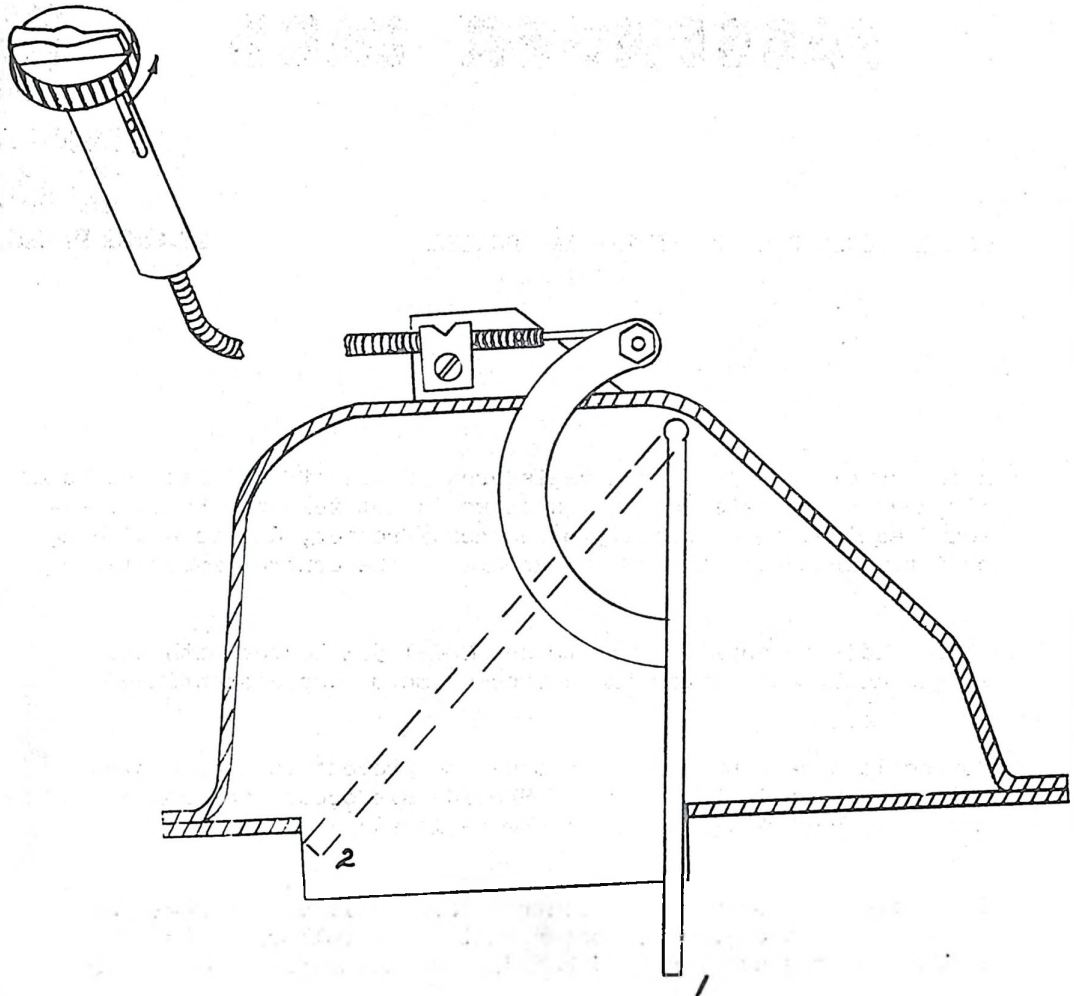
FIGURE 1

Improper adjustment of the control cable will also affect the full operation of the defroster unit. The following sketch shows how this cable should be adjusted at the control valve.

1. Defroster valve in closed position.
2. Defroster valve in open position (dotted line).

The control knob should turn approximately one (1) full turn in order to close or open the defroster valve.
