SERVICE BULLETIN

No. D-11

Parking Brake
Adjustment

D41 - D42

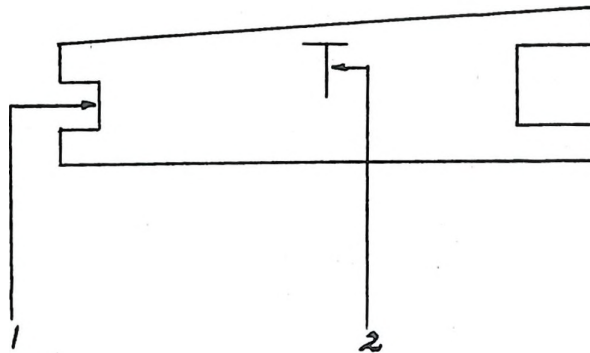
FIGURE 1

NOTE. The letter "T" is stamped on the upper side of the link.

OPERATING LINK

1. File bottom of this opening.
2. Install link with "T" on top side.

It should always be installed with this identification at the top. This is very important.

When the link is correctly installed and excessive up and down movement is still noticeable, remove the link and file the small slot in the link (Fig. 1) until the shoe fits snugly against the anchor stud, and the lower end of the operating lever does not ride on the brake shoe. This lever should have some free movement, with the brake cable disconnected from the lever. Do not remove any more metal than necessary, as excessive filing will cause the link to rattle and will increase the brake lever travel, thereby decreasing the efficiency of the brake.

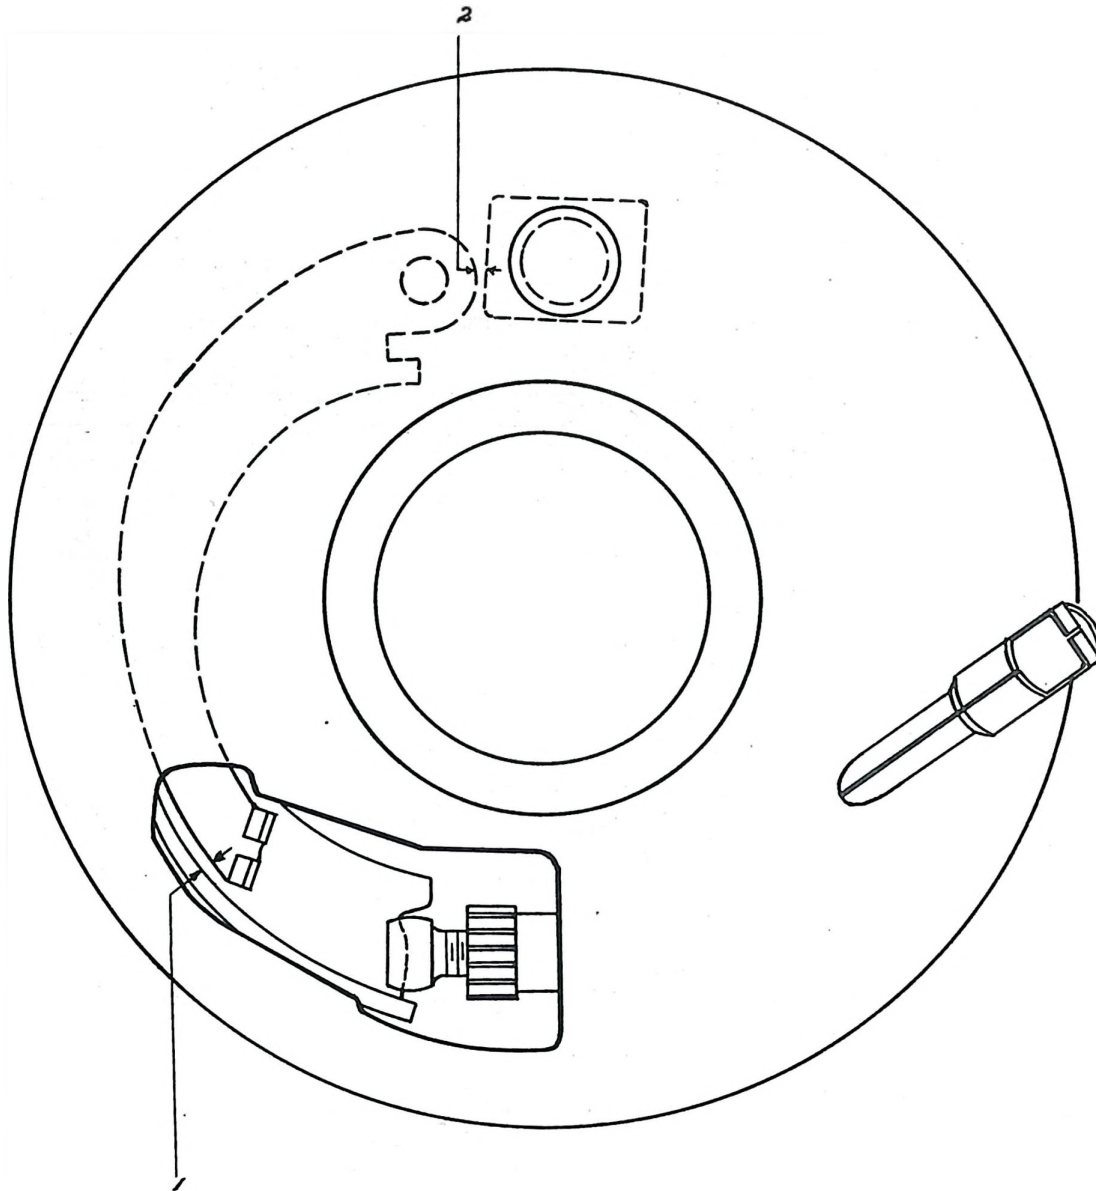
FIGURE 2

(1.) Lever must not contact brake shoe--must have small amount free play when cable is detached. (2.) Must have clearance at this point.

4. Remove any excessive paint from the support plate or rough edges on the brake shoe lugs at the points where the brake shoe lugs contact the support. This is necessary to allow the shoes to center themselves properly and prevent possible dragging of the shoes and chattering of the brakes.
5. Interference has been found between the edge of the inner guide and the pivot end of the operating lever (Fig. 2, #2). This can be eliminated by filing a small amount of material from the end of the lever or from the edge of the guide.

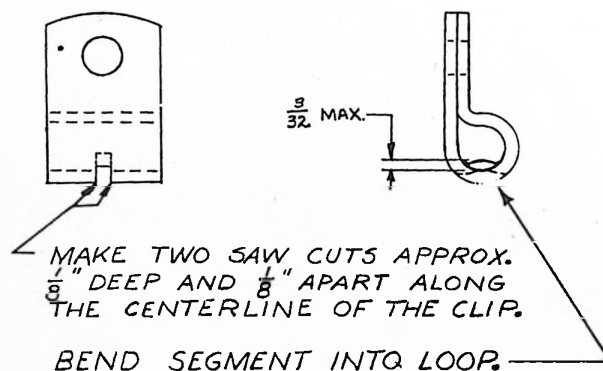
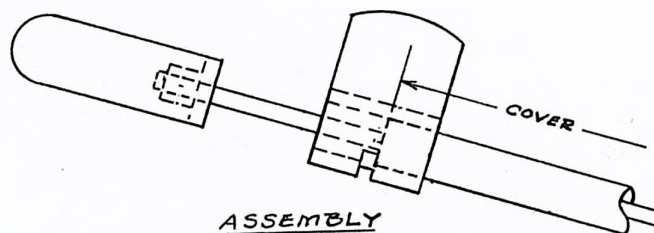
FIGURE 1

In some cases, it may be difficult to maintain a proper fit of the hand brake cable cover in the clamp of the transmission brake support of Dodge cars equipped with the new internal hand brake. This is due to the excessive relative distance between the lower end of the cable cover and the ball end of the cable itself rather than an excessive length of the cable. This condition is usually the result of insufficient distance between the upper end of the cover and the clevis caused by incorrect spacing between the instrument panel handbrake lever bracket and the cable clip on the body bracket. In other words, the cable cover is not moved far enough down the cable in the assembled position. The spring at the lower end should be compressed to a maximum of 6".

A relatively simple correction can be made by forming a stop in the middle of the clip as shown in the following sketch, thus forcing the cover farther down the cable.

Care should be taken that the clip still has sufficient clamping force to prevent the cover from being forced out of the clip when releasing the brake. The stop should not extend into the loop of the clip more than the 3/32" shown on the sketch or it may interfere with the cable itself.

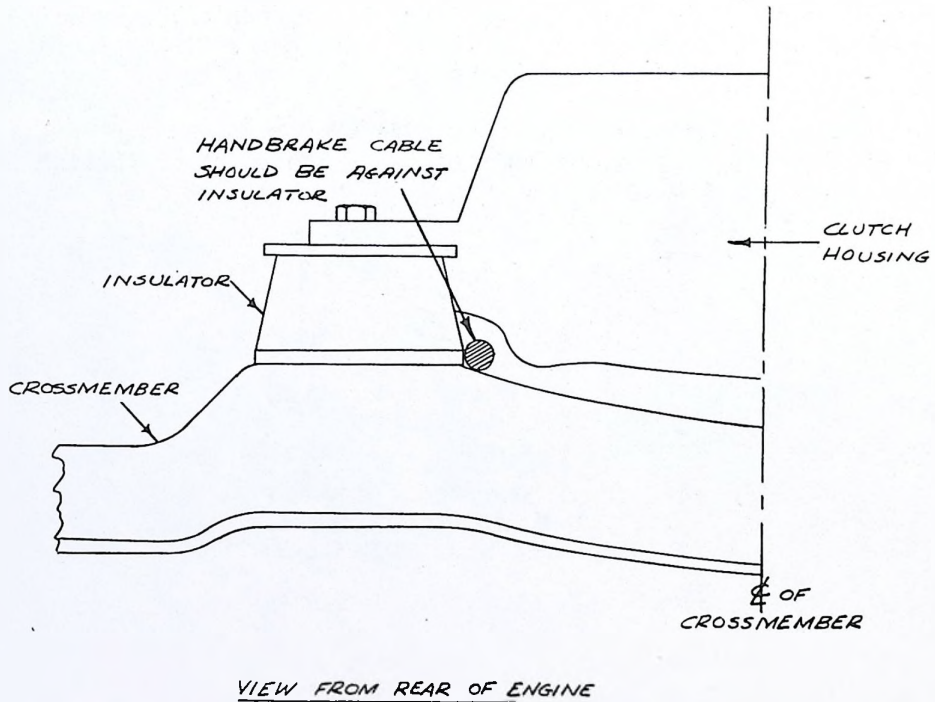
FIGURE 2

Another condition may exist that will also affect the operation of the brake and that is the improper location of the brake tube and cable assembly. Instances have been found where the brake tube assembly have been jammed between the clutch housing and the crossmember which damages the tube and will interfere with the proper operation of the brake. This condition may result in complaints of rough engines or idle, as the tube will not allow the engine to move on the rubber mounting.

The brake cable assembly should be installed as shown on the following sketch.

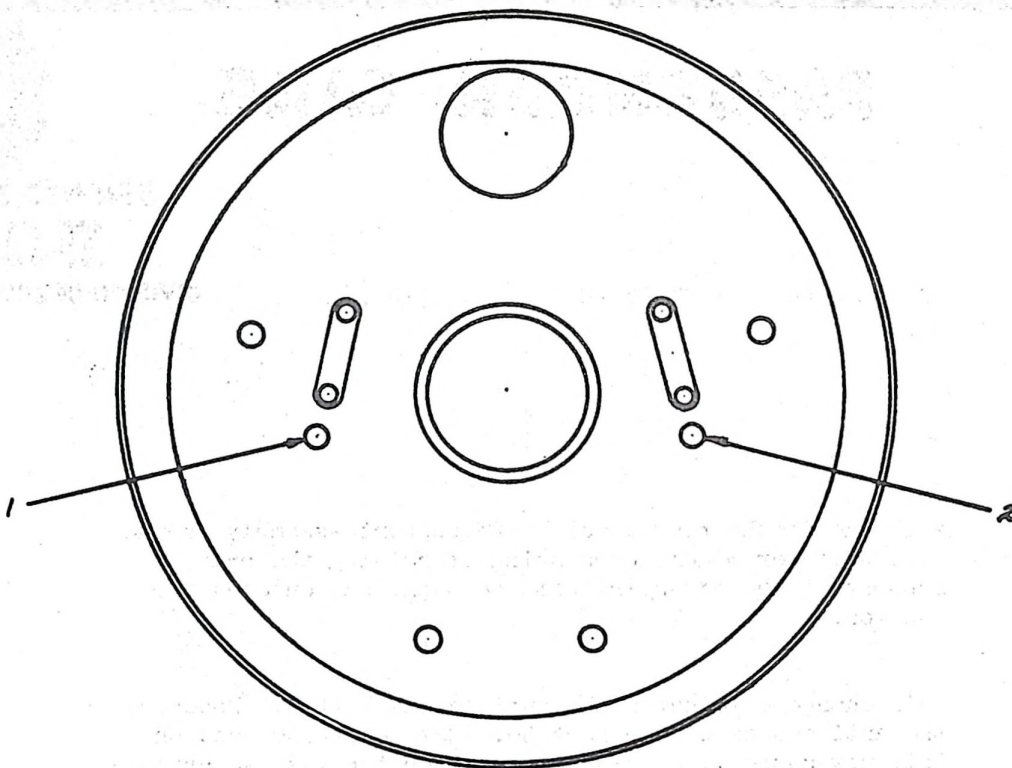
FIGURE 1

A change in the rear wheel brake support assembly on the D-41 Wayfarer models consisting of raising the brake support at the adjusting cam location, has entered production.

This new brake support can be readily identified by a raised circular section approximately 1/16" high by 3/8" in diameter, directly below the brake shoe hold down clip rivets.

This raised section is visible without removing the brake shoe.

This change eliminates the anti squeak button. However, the anti squeak washer Part No. 1327054 can be used on this new support, should the occasion for its use arise.

Under no circumstances should the anti squeak button be used, as it will result in cocking the brake shoe out of line.

The Part Number of the new brake support is #1404983.
