SERVICE BULLETIN

No. D-34-A

Stalling Of
Engine Due To
Failure Of
Interrupter
Switch

D41 - D42

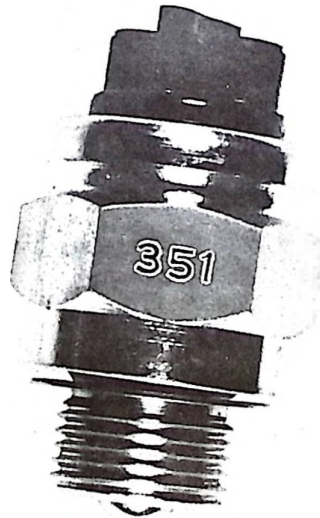
FIGURE 1

Complaints of engine stalling immediately after a kickdown or a governor downshift from fourth to third gear have been registered. After such stalling the engine may not start until the engine cools down and in some cases will not start at all. Investigation has disclosed that this condition may be caused by the failure of the diaphragm in the ignition interrupter switch assembly.

Improvements were incorporated into the interrupter switch which will eliminate this stalling condition. These improved interrupter switches entered production at engine D42-239562 and can be identified by the number that is stamped on the hexagonal part of the switch. (See Sketch) All switches that are numbered 351 or higher should operate satisfactorily.

Should this condition exist, a simple check can be made to determine whether the interrupter switch is at fault. Remove the two wires (black and green) from the ignition coil. If the engine performs satisfactorily when these wires are removed the interrupter switch should be replaced.
