IMPORTANT *Service* INFORMATION

DATE	NUMBER
11-16-55	730
GROUP	
Engine	
SUB-GROUP	
Manifold Heat Control Valve

DATE	NUMBER
4-18-56	785
GROUP	
Engine	
SUB-GROUP	
Engine Oil Filter Base

DATE	NUMBER
4-18-56	786
GROUP	
Engine	
SUB-GROUP	
Intake Manifold

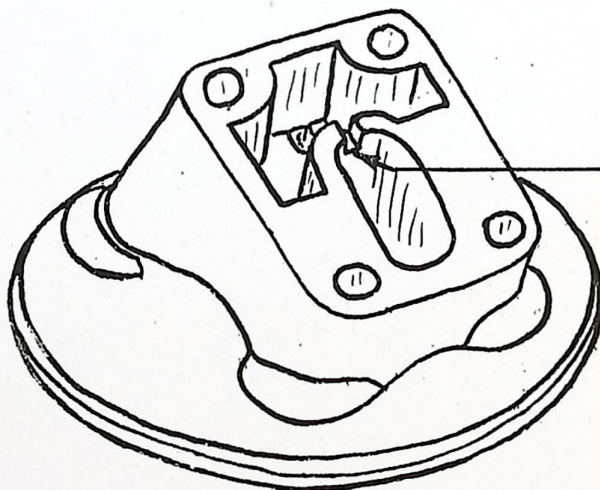
The engine oil filter base is provided with a by-pass slot, as indicated in sketch, for the purpose of supplying oil to the main oil galleries should the filter become clogged or restricted.

Be sure to check the filter base by-pass slot for correct size (1/8" wide - 1/8" deep) and the filter for restrictions on any complaint involving low pressure - loss of oil pressure at high speeds and, in every instance, where crankshaft and rod bearing failures are experienced.

1/8" x 1/8"
By-Pass Slot
