Service Bulletin

No. 59-36

ENGINE

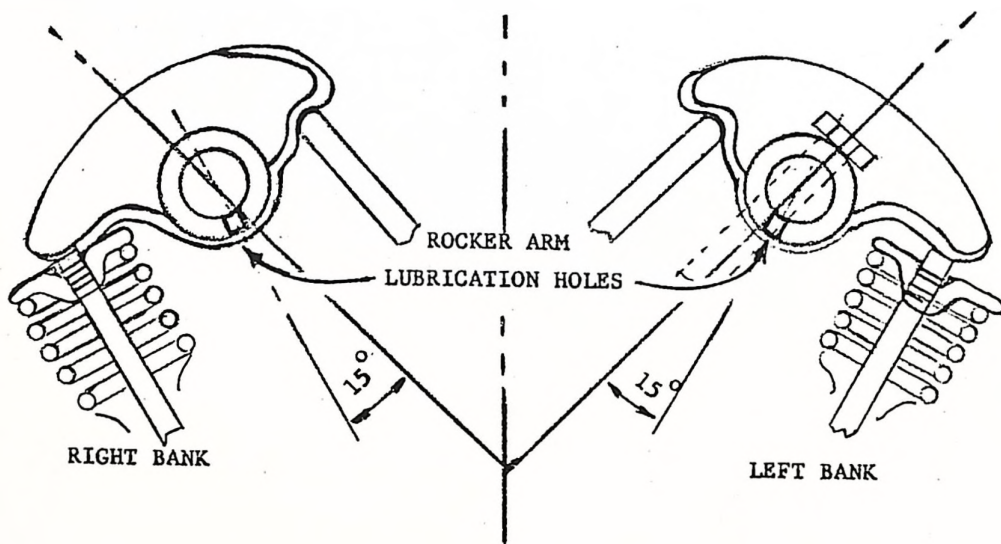
During the latter part of 1959 engine production, starting with engine numbers approximately MR383-17000, MR413-16000, the arrow identification on the rocker shafts was omitted. However, the rocker shafts can be readily identified by other means to allow correct assembly.

Should it be necessary to remove or replace the rocker shafts on 1959 Chrysler and Imperial engines of later engine numbers, and one or both rocker shafts does not carry the arrow identification, the following procedure will insure correct installation:

Note: The 15⁰ angle of the rocker arm lubrication holes is determined from the center line of the bolt holes through the shaft which are used to attach the shaft and brackets assembly to the cylinder head.

It is important that the rocker arm shafts are installed, as outlined above, otherwise excessive oil spray and improper lubrication of the valve train components can result.

Install the rocker shafts so that the 3/16 inch dia. rocker arm lubrication holes point downward into the rocker arm and so that the 15° angle of these holes points toward the valve end of the rocker arms. See sketch below:
