Service Bulletin

No. 59-50

EXHAUST

RESONANCE
OR
PERIOD

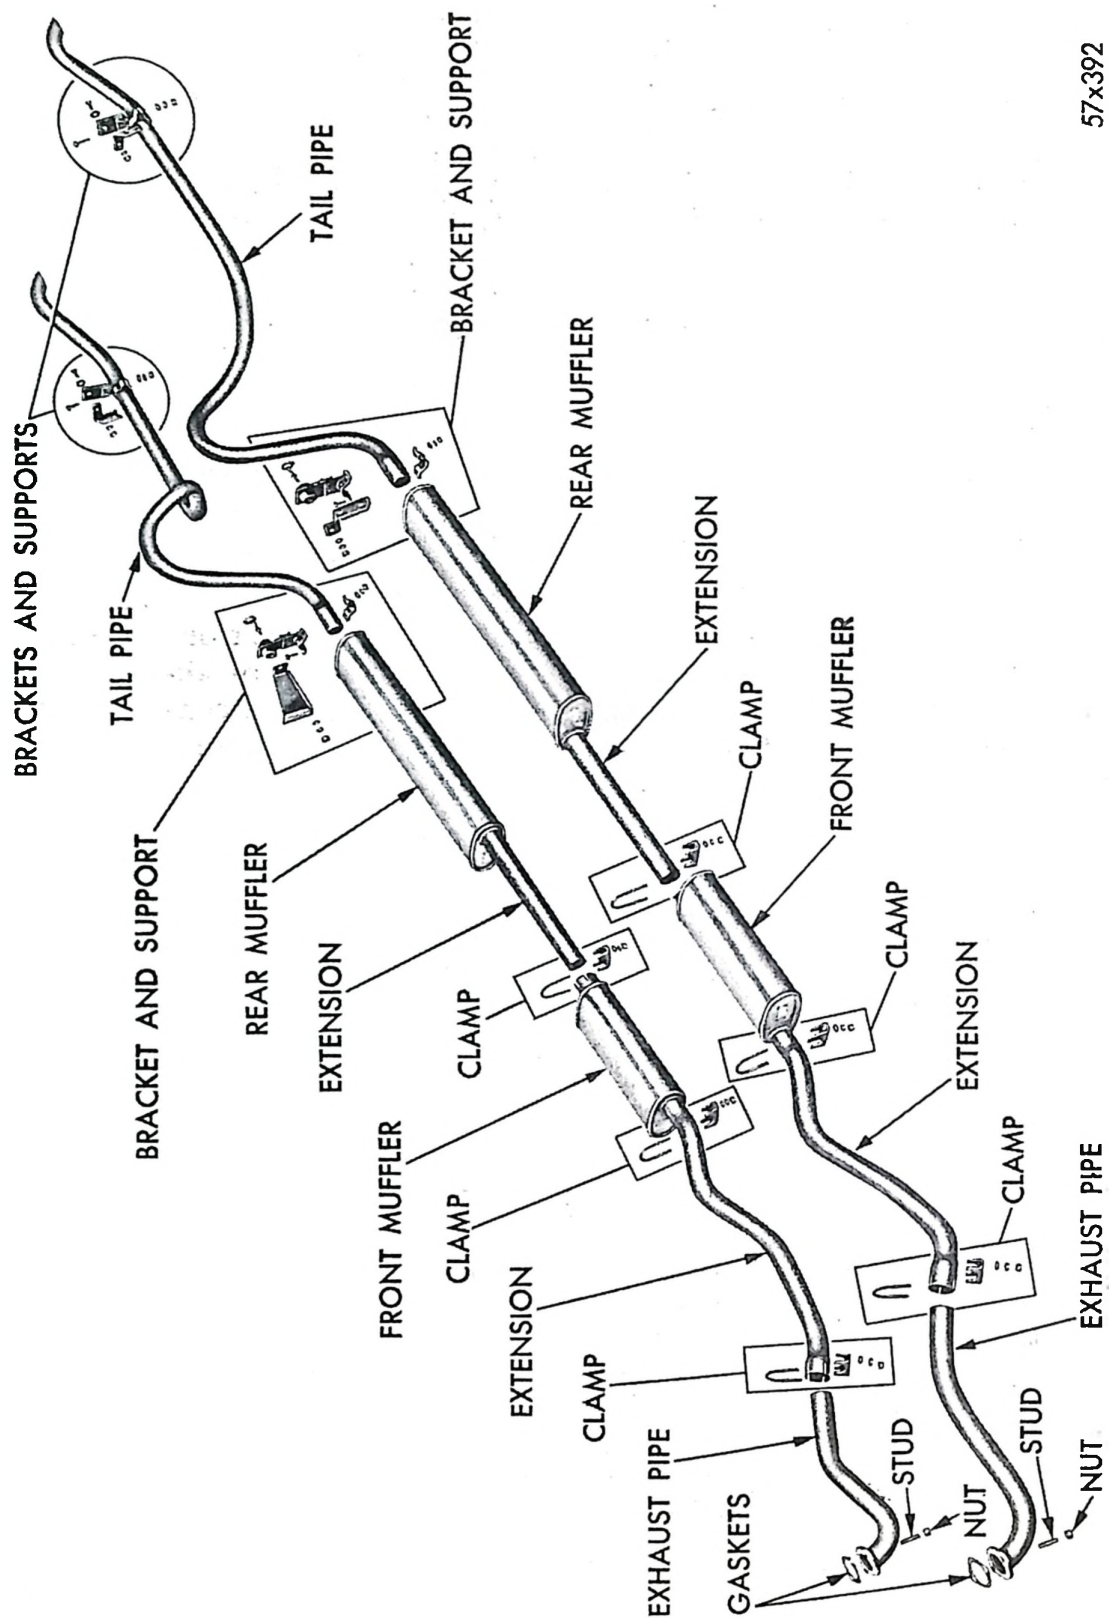
57x392

If you experience an exhaust resonance or period which may be misinterpreted as an engine vibration, the information in this bulletin may be of assistance to you.

The most likely cause of this condition is usually the misalignment or abnormal stressing of the exhaust system added to other normal or abnormal conditions. Therefore, it is recommended that when this condition is encountered that the diagnosis and corrections be performed following the procedure outlined below:

- (3) General tightening of all chassis and body parts that might vibrate. Tighten the exhaust manifolds to the cylinder heads.
- (4) Loosen entire exhaust system (see illustration). Neutralize, align and tighten the entire exhaust system at each point of junction. It is very important that every part of the exhaust system is properly aligned and supported. The supports must carry the load in a truly vertical line, and the large diameter center of the oval muffler ellipse is in a true transverse horizontal plane. In some cases it may be necessary to heat the exhaust pipes and slightly bend them to obtain satisfactory alignment. Be sure the tail pipes are accurately located between the fuel tank and frame side member. Be sure that the support metal members are satisfactorily insulated and do not contact each other.
