Technical Service Bulletin

NUMBER 67DT-21 MODEL D100 WITH SIX CYLINDER ENGINE

GROUP FRAME SUBJECT FRAME & ENGINE SUPPORT REINFORCEMENT

SUMMARY REINFORCEMENTS ADDED TO FRAME & ENGINE SUPPORT BRACKETS

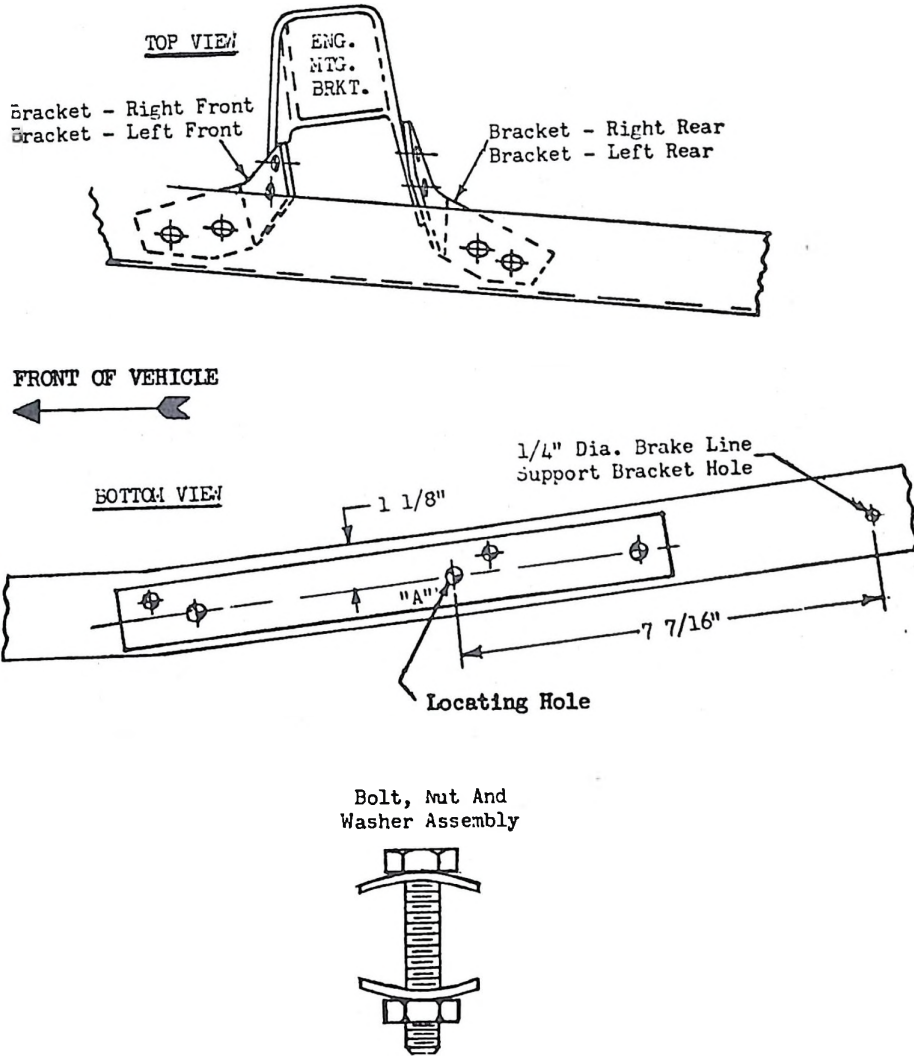
FIGURE 1. FRAME BRACKET & PLATE PACKAGE INSTALLATION

Frame bracket and plate package (P/N 2808688) may be installed on six cylinder equipped model D100 trucks (having serial number which fall between 1161-492000 and 1161-682239) if cracks develop in the frame at the engine support area.

1. Raise front end of truck, supporting weight on front bumper. Remove engine mounting bolts and raise engine about 1/2" off mounting brackets.
2. Repair any existing cracks by arc welding before the enclosed parts are installed.

3. Drill a 3/8" hole in lower flange of rail at point "A", as indicated in bottom view.
4. Attach reinforcement plate to lower flange of rail. Plate must be parallel to lower frame flange as shown in bottom view. Drill remaining four (4) 3/8" dia. holes in lower flange of rail using reinforcement plate as template.

5. Attach both engine support brackets to lower flange of frame. Be sure vertical leg of support brackets are against engine mounting bracket. Drill two (2) 3/8" dia. holes in both sides of engine mounting brackets using support brackets as template (See top view).

6. Use same procedure on the right side.
7. Paint to improve appearance and prevent rust.

CAUTION: DO NOT WELD BRACKETS IN PLACE
