# SERVICE BULLETIN

No. D-170

FLUID COUPLING

SQUEAL

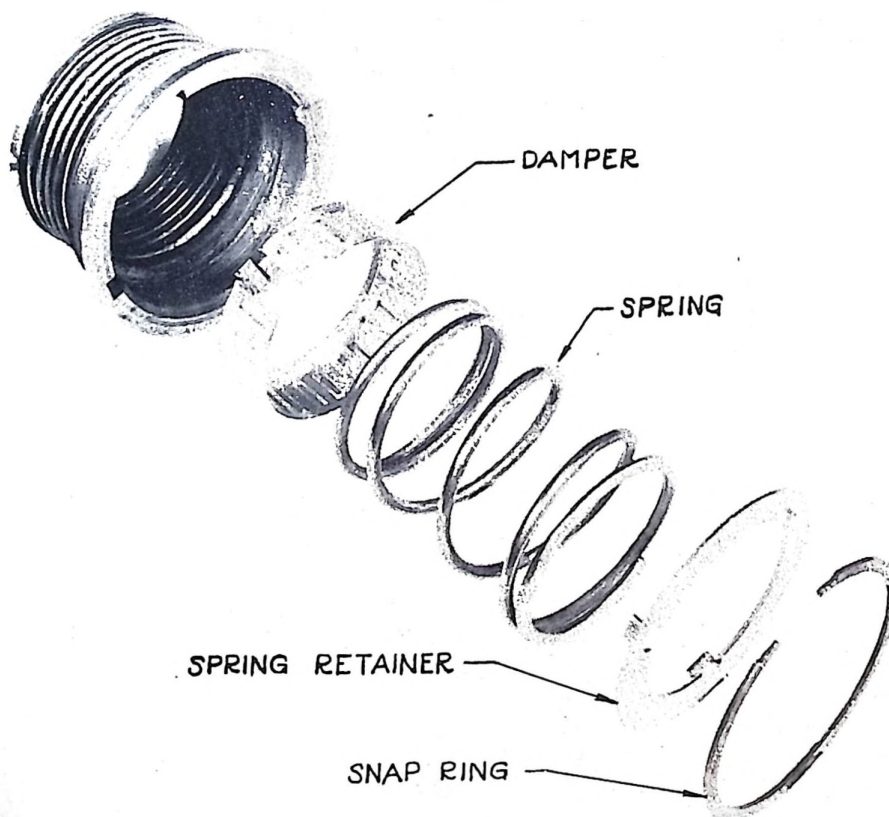
A few D-24 Dodge Cars have a squealing noise in the fluid drive which is most noticeable at low speeds. It also occurs whenever the car, with the transmission in gear, is held with the brake and the motor accelerated. This noise will disappear completely whenever the clutch pedal is depressed. Although this noise is sometimes annoying, it is in no way harmful to the car.

Effective Car Serial #30727536 a damper was added to the fluid coupling seal assembly to prevent fluid coupling seal squeals. An exploded view of the damper and its adjoining parts is shown below.

This damper (Part #1112754) is available for service and should be installed in case of persistent squeal in cars built before the effective serial number. The procedure outlined in Bulletin #D-159 of replacing the seal ring should no longer be followed. It is now only necessary to replace the ring when signs of leakage are evident.

7. Install damper (Part #1112754) over front end of spring, replacing spring with a counter clockwise twist to insure proper seating of spring and damper in bellows. Reinstall spring retainer and snap ring again using Miller Tool #C-613 to compress the spring.
