IMPORTANT Service INFORMATION

DeSoto

SUBJECT: RADIO WARRANTY SERVICE - 1960 DE SOTO RADIO

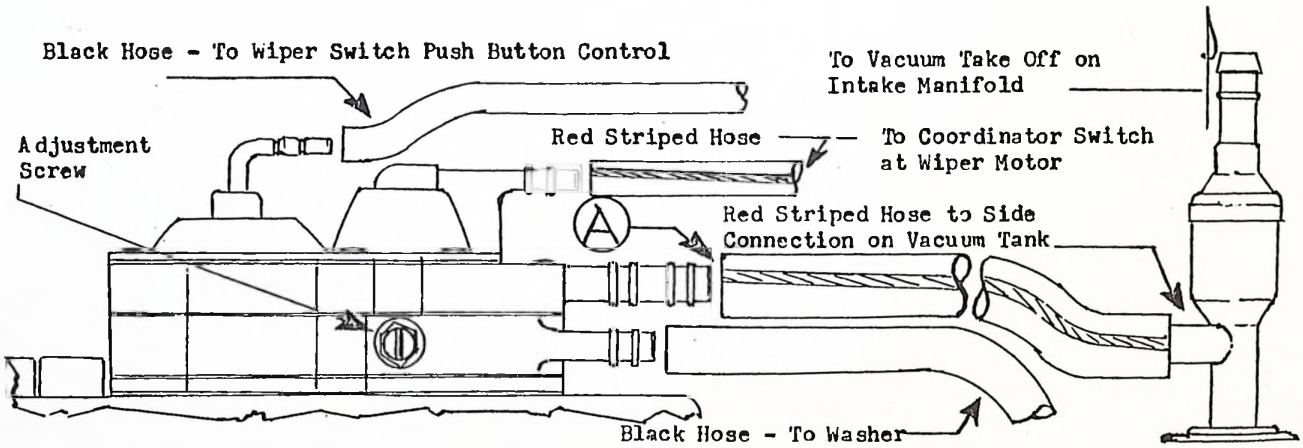
WINDSHIELD WASHER CONTROL ON RESERVOIR

On 1960 De Soto cars equipped with windshield washers it is extremely important that all operating hoses be correctly installed as shown in the following sketch. For identification purposes, the hoses are either black, or black with a red stripe, and all hose connections are either marked with a daub of red paint or are unmarked. Black hoses must be installed at unmarked connections and red striped hoses are attached to the connections marked with red paint.

Important: The short red striped vacuum hose from the side connection of the vacuum reserve tank must always be installed on the connection indicated by arrow "A" above. On early built cars these two hoses are the same diameter and can be reversed, resulting in possible engine damage.

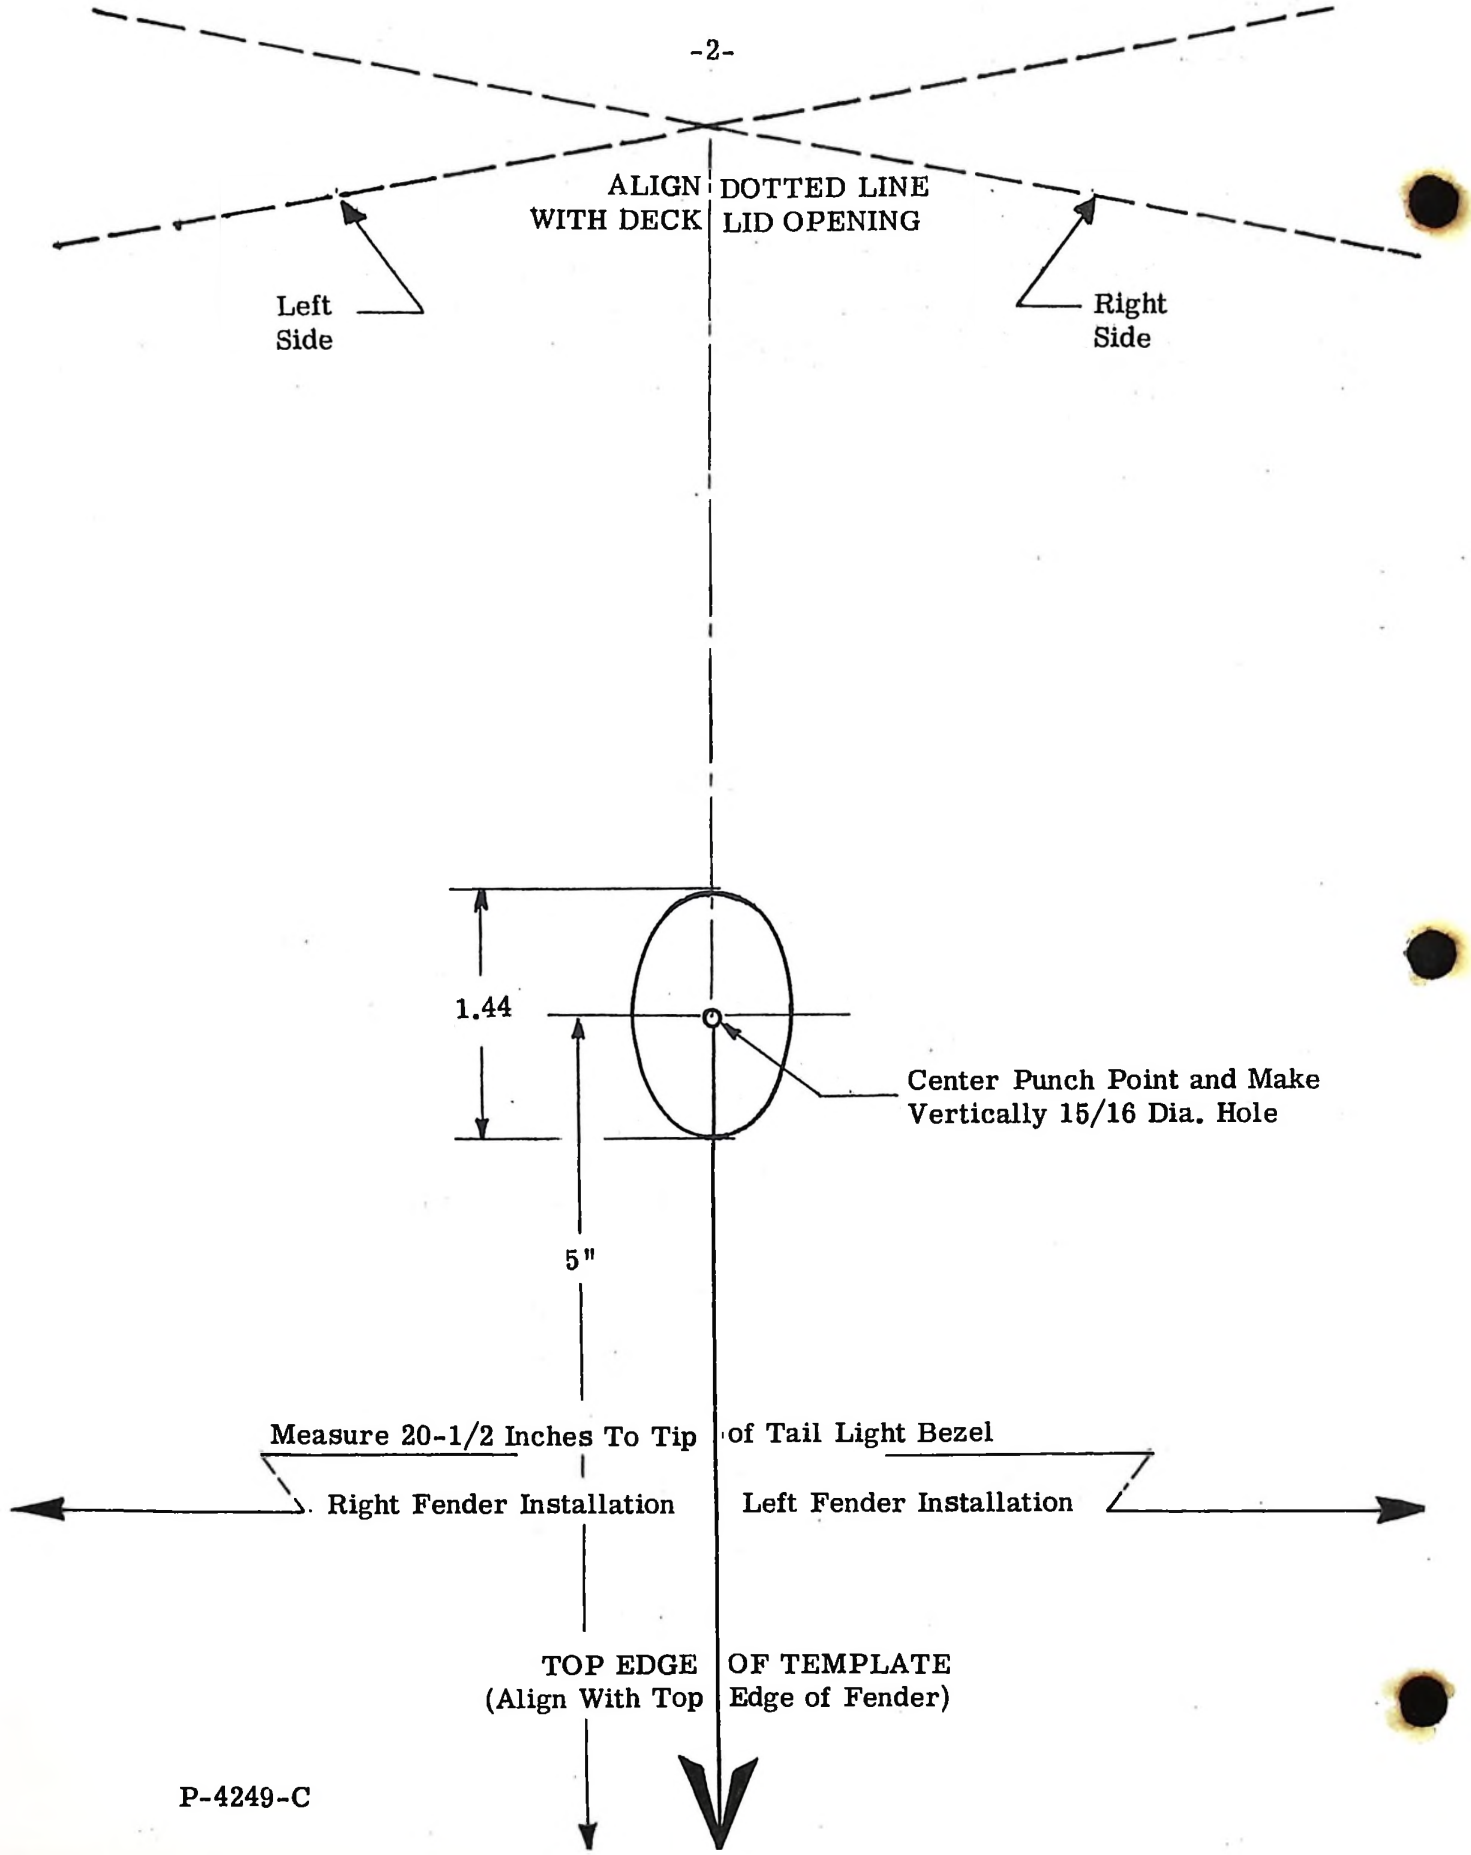
This bulletin will assist in properly locating and installing 1960 De Soto rear fender mounted radio antennas. Locating dimensions and hole sizes are shown on the back of the bulletin and should be used to fabricate a template that will insure correct installation of single or dual antennas. When making the template, it is advisable to use a sheet of paper or cardboard the same size as the bulletin. Be sure the vertical centerline of the antenna hole is centered on the template and exactly at right angles to the top edge of the template, as shown. This will make the template applicable for both right and left fender installation.

1. From the upper rear tip of the tail light bezel, measure forward along the top edge of the rear fender 20-1/2 inches to locate the vertical centerline of the antenna hole. Locate the vertical centerline shown on the template at this point, and position the template so the top edge lines up exactly with the top edge or peak of the fender.

2. Bend the template down the inner side of the fender so the dotted line at the bottom is in alignment with the deck lid opening. Locate, center punch and vertically drill a 15/16 inch dia. hole to required oval shape, as shown on the template.

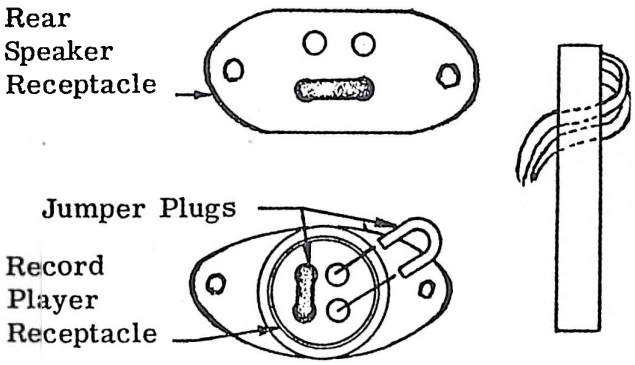
RADIO - RIGHT REAR CORNER VIEW

NOTE: When the record player adapter cable is removed from the receptacle on the radio, the radio becomes inoperative unless metal jumper plugs are installed as shown in sketch.
